INDOOR AIR QUALITY ASSESSMENT

**Massachusetts Board of Bar Overseers
New Suffolk County Court High-rise
3 Pemberton Square
Boston, Massachusetts**

Prepared by:
Massachusetts Department of Public Health
Bureau of Environmental Health
Emergency Response/Indoor Air Quality Program
June 2007

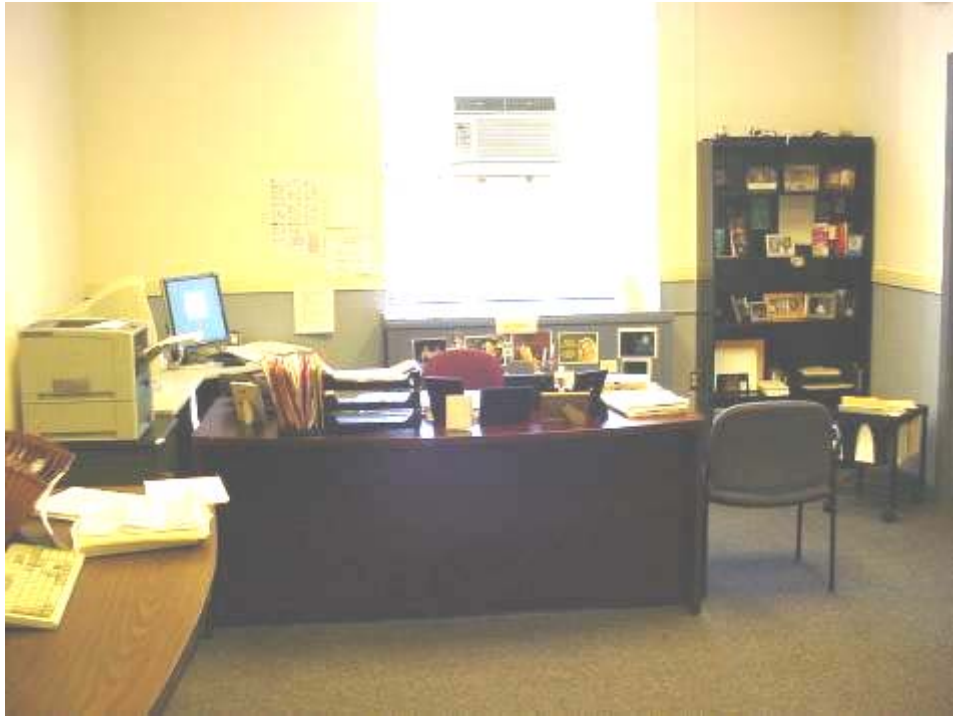
Picture 1

Temperature measurements ranged from 70° F to 74° F, which were within the MDPH recommended comfort guidelines in all areas surveyed during the assessment. The MDPH recommends that indoor air temperatures be maintained in a range of 70° F to 78° F in order to provide for the comfort of building occupants. Although temperatures measured were within MDPH guidelines during the assessment, complaints regarding thermal discomfort were reported to CEH staff. This discomfort is likely due to the close proximity of the occupant's desk in the airstream of the univent (Picture 1).

Desk and Chair in Front of Univent

1. Move office desks and chairs a minimum of 5 feet away from univents.
2. For buildings in New England, periods of low relative humidity during the winter are often unavoidable. Therefore, scrupulous cleaning practices should be adopted to minimize common indoor air contaminants whose irritant effects can be

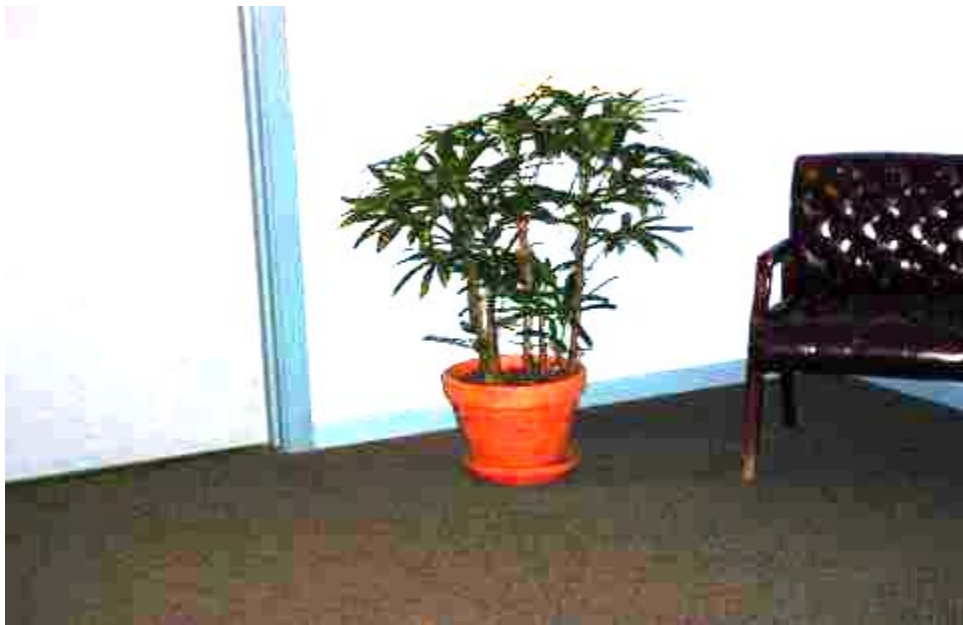
Picture 2

Plants were observed in a number of rooms within the MBBO. Moistened plant soil and drip pans can provide a source of mold growth and pollen. Plants should be located away from the air stream of ventilation sources to prevent the aerosolization of mold, pollen or particulate matter. Plants should have drip pans to prevent wetting of porous building materials and subsequent mold colonization. Over watering of plants should be avoided and drip pans should be inspected periodically for mold growth. Plants should not be placed on carpeting (Picture 2). A water cooler was also observed on top of carpeting. A plastic mat should be installed beneath the water cooler to prevent wetting of the carpet and subsequent mold growth.

Plant on Carpet

3. Remove plants from direct contact with carpeting and from the air stream of univents. Ensure all plants are equipped with drip pans. Examine drip pans for mold growth and disinfect areas of water leaks with an appropriate antimicrobial where necessary.
4. Place a water impermeable plastic mat beneath the water cooler.
